# Manhole Inspection Summary

Manhole # S57C\_\_008MH

**Inspection** ☐ Is Incomplete Rating: **4) Poor**

**Location** Address: **3800 E.Baltimore St.**

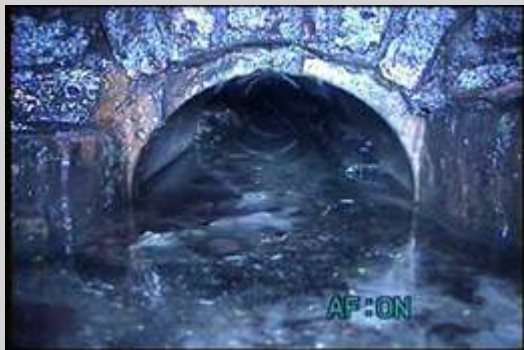
12 O'Clock Outflow

12 in. Circular Gravity Sewer  
Pipe Out @ 12 O'Clock

Pipe Height: **12** (in.) Rod and Bar (Angled)  
Pipe Material: **Clay** ☐ Pipe Lined  
Invert Depth: **10.24** (ft.) Flow Characteristics: **None**  
Deposits: ☒ None ☐ Mud ☐ Sludge ☐ Debris ☐ Grease  
Silt Depth: **0** (in.) Deposits Extent:  
Infiltration: **None** Pipe Seal Cond: **Sound**

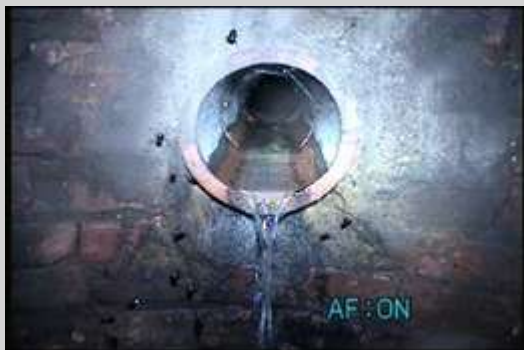
8 O'Clock Inflow

8 in. Circular Gravity Sewer

Pipe In @ 8 O'Clock

Pipe Height: **8.4** (in.) Rod and Bar (Angled)

Pipe Material: **Clay** ☐ Pipe Lined

Invert Depth: **6.50** (ft.) Flow Characteristics: **None**

Deposits: ☒ **None** ☐ Mud ☐ Sludge ☐ **Debris** ☐ Grease

Silt Depth: **0** (in.) Deposits Extent:

Infiltration: **None**

Pipe Seal Cond: **Sound**

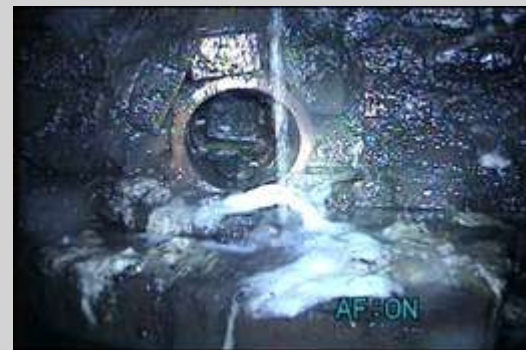
Drop In @ 8 O'Clock

Drop: **Outside** Rod and Bar  
Angled: **Yes** Reading: **8.50** (ft.)  
Inv Depth: **9.50** (ft.)

Drop Condition: **Open**
